Docket No. 217 – Development and Management Plan Inspection

Northeast Utilities Service Company Certificate of Environmental Compatibility and Public Need for the construction of a 345-kV electric transmission line and reconstruction of an existing 115-kV electric transmission line between Connecticut Light and Power Company's Plumtree Substation in Bethel, through the towns of Redding, Weston, and Wilton, and to the Norwalk Substation in Norwalk, Connecticut.

Norwalk Substation

Date: June 28, 2006

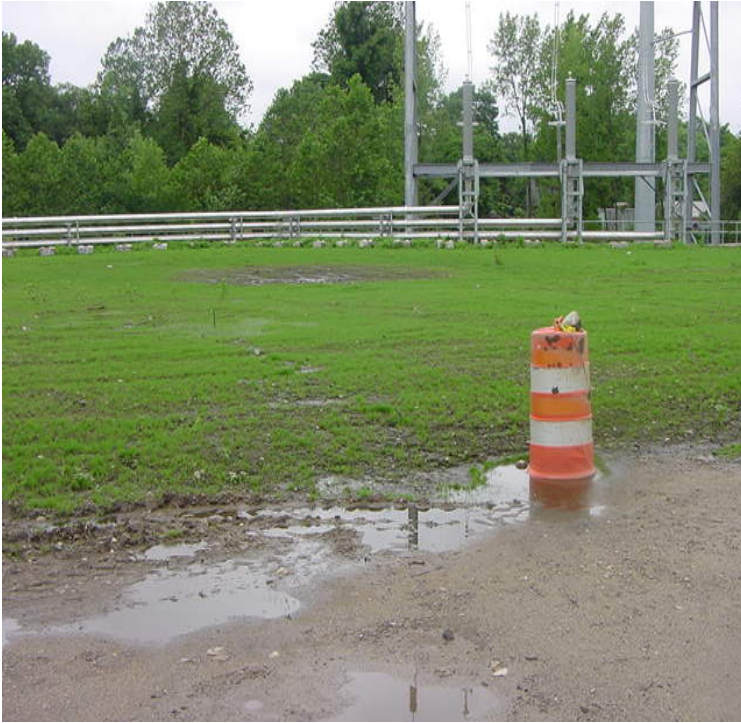
Norwalk Substation: Photo on the left shows the recently hydroseeded area near the GIS building. Grass growth continues to increase here. Watch the catch basin in this area for turbid run-off
Photo on the right shows the bike path which was continued north of the substation through the ROW to Broad St. 6/29/06.

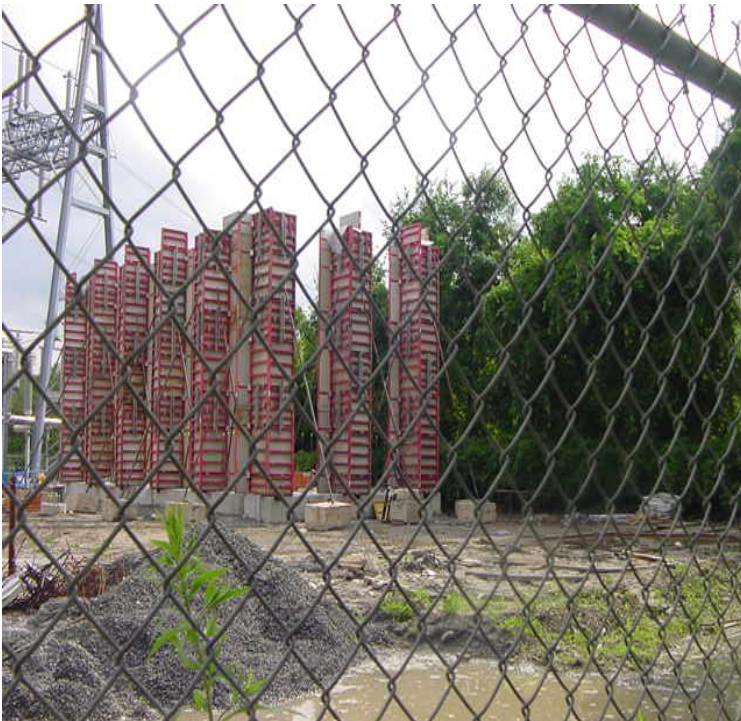
Plumtree Substation: Photo on the left shows recently poured forms where structure work continues. Photo on the right shows turbid water pooling in the wetland swale near the entrance to the yard. Silt fence or haybales may be necessary due to run-off from the access drive. 6/29/06

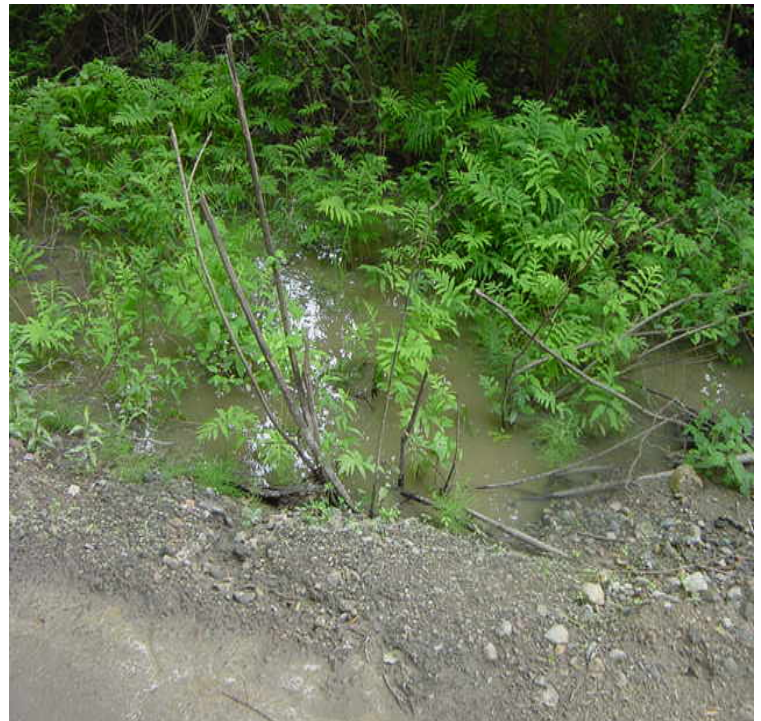
-Turbid water was noted in the wetland swale at the entrance to the yard 6/28/06	- Consider placing silt fence or haybales to reduce run-off from the access rd 6/28/06	- Needs evaluation
Inland Wetland and Watercourse encroachment and mitigation	- Wetlands are located around the outskirts of the substation yard. 6/28/06	- Maintain perimeter berm. Vegetation adjacent to the yard is thick and helps filter run-off. 6/28/06.	N/A.
State species of concern, threatened and endangered species	- The wood turtle was seen along the outside perimeter of the station the week of 5/25/06.	- Move machinery carefully and perform daily walkdowns of the site. Watch carefully for the turtle as this is the most active time of year. 5/25-6/28/06.	-Daily walkdowns should be occurring at this point with crews remaining aware of machinery and open trenches throughout the day.
